FACILITY STATUS CHANGE FORM

Date Submitted: April 11, 2013 Originator: Chris Strand Phone: 554-2720	Area: 300 Area Facility ID: 3906A Action Memorandum: Action Memorandum #3	Control #: D4-300-084
---	---	---------------------------------

3906A Lift Station

Attachment 2: Project Photographs

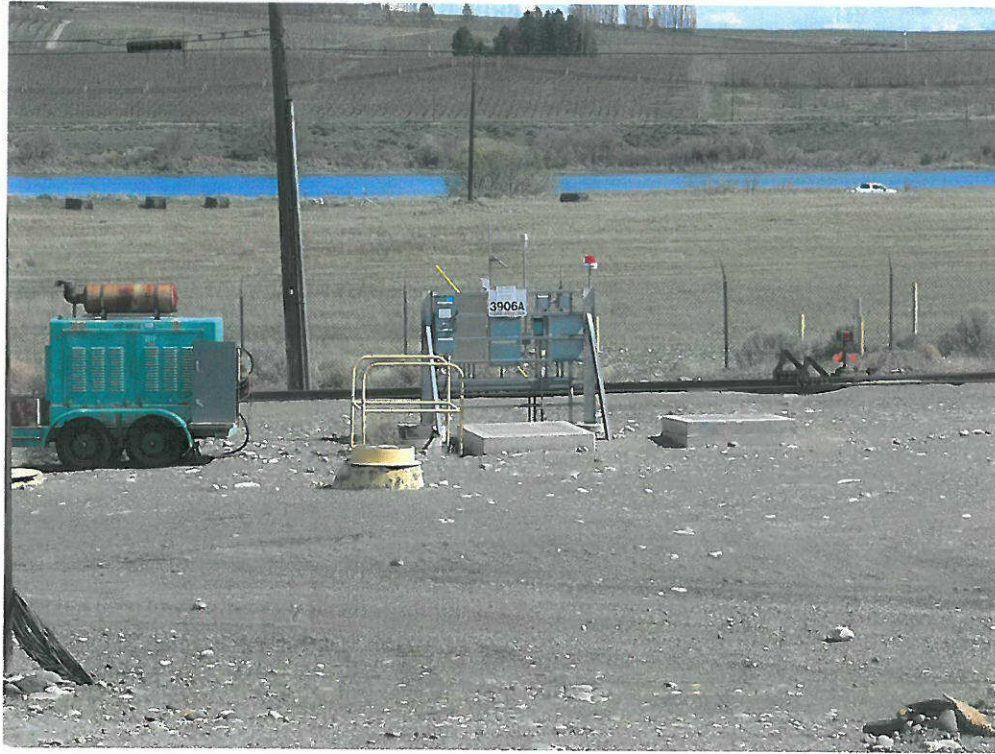
Photograph 1: 3906A, looking east, March 31, 2006.

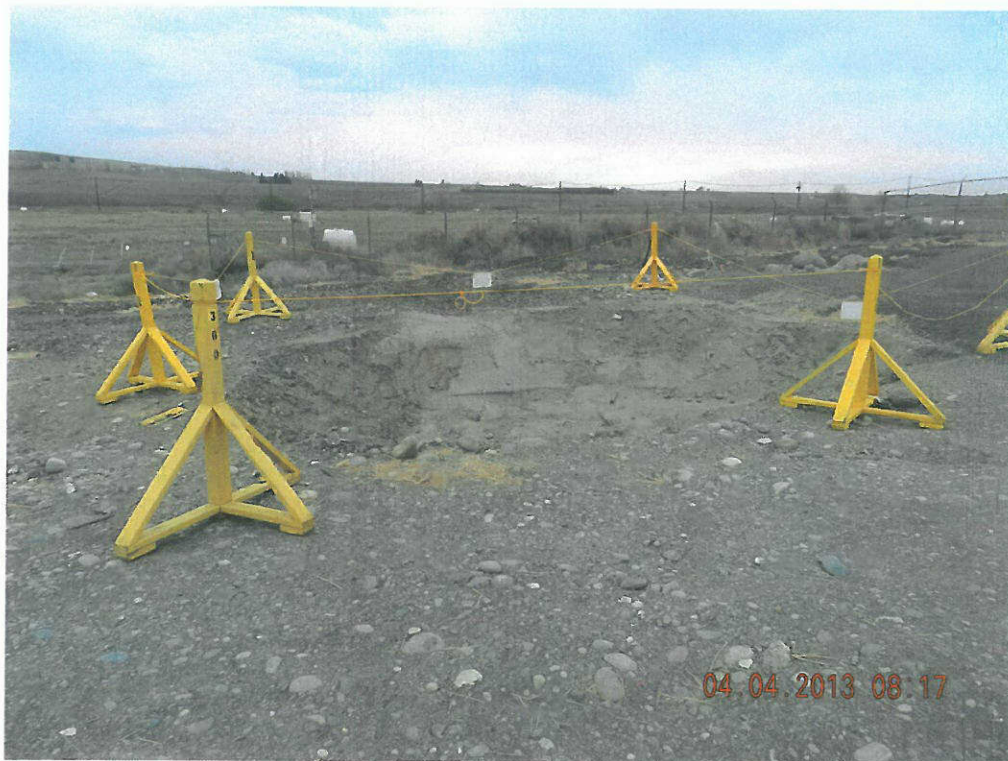
No anomalies were discovered during demolition of the below-grade portion. Post demolition soils displayed no visual evidence of staining or discoloration. A final GPERS survey of the excavation following below-grade demolition identified no radiological contamination.

Photograph 2. 3906A excavation, looking southeast on April 4, 2013.

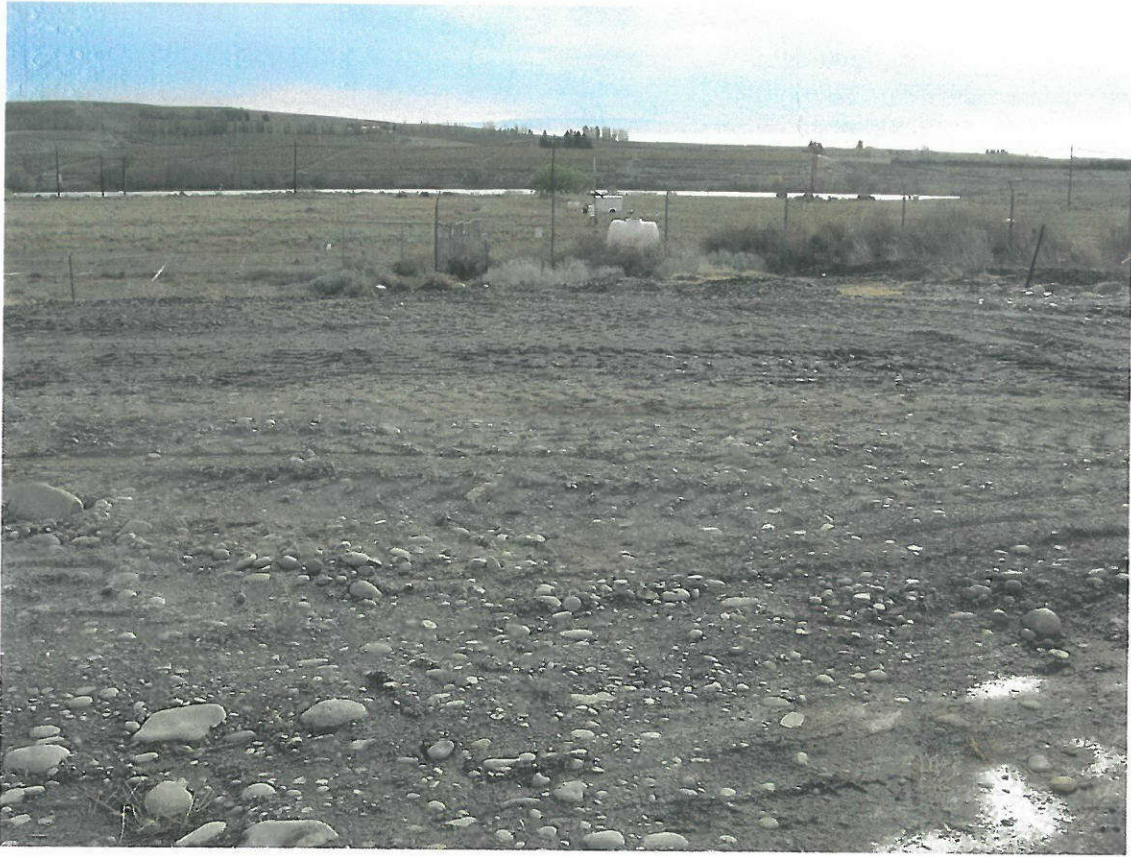
All above-grade structures and the below-grade portion to minus 3 feet were removed. Excavations were backfilled to grade with clean fill. GPERs surveys were performed prior to backfill. No radiological or Industrial Hygiene postings remain.

Photograph 3. 3906A following backfill, looking east on April 11, 2013.
